Contract #: 04-0120F4Cty: SF/ALA Rte: 80 PM: 13.2/13.9File #: 13.28**WELDING INSPECTION REPORT****Resident Engineer:** Pursell, Gary**Address:** 333 Burma Road**City:** Oakland, CA 94607**Report No:** WIR-009195**Date Inspected:** 22-Sep-2009**Project Name:** SAS Superstructure**OSM Arrival Time:** 1500**Prime Contractor:** American Bridge/Fluor Enterprises, a JV**OSM Departure Time:** 2330**Contractor:** Oregon Iron Works Clackamas, Or.**Location:** Clackamas, OR**CWI Name:** Steve Barnett**CWI Present:** Yes No**Inspected CWI report:** Yes No N/A**Rod Oven in Use:** Yes No N/A**Electrode to specification:** Yes No N/A**Weld Procedures Followed:** Yes No N/A**Qualified Welders:** Yes No N/A**Verified Joint Fit-up:** Yes No N/A**Approved Drawings:** Yes No N/A**Approved WPS:** Yes No N/A**Delayed / Cancelled:** Yes No N/A**Bridge No:** 34-0006**Component:** Hinge-K Components**Summary of Items Observed:**

Summary of Items Observed: On this date, Caltrans Quality Assurance Inspector (QA) Clete Henke was present at Oregon Iron Works, Inc. (OIW) in Clackamas, OR for observation of fabrication of the Hinge K Pipe Beams and related activities including in process welding and OIW Qualit

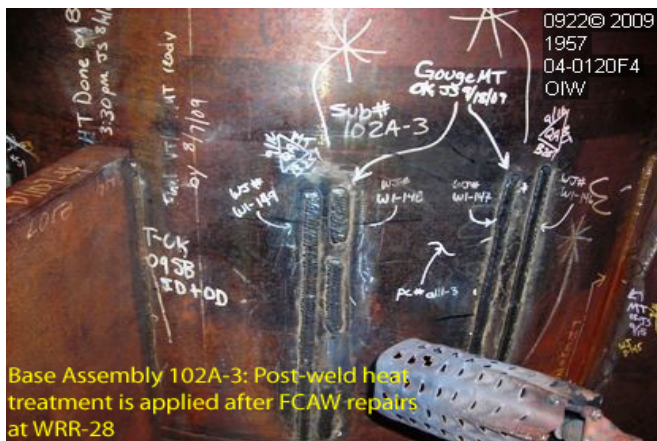
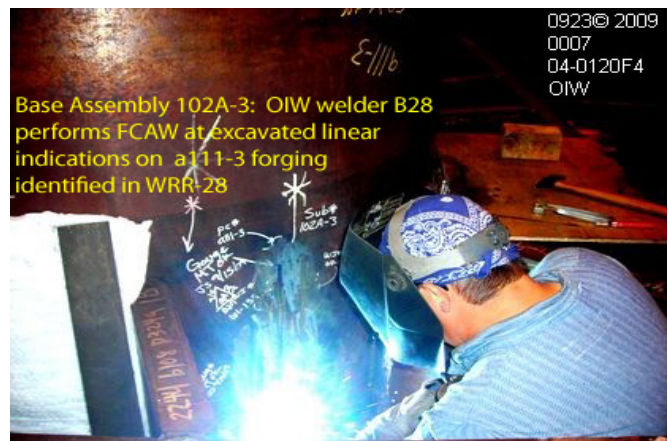
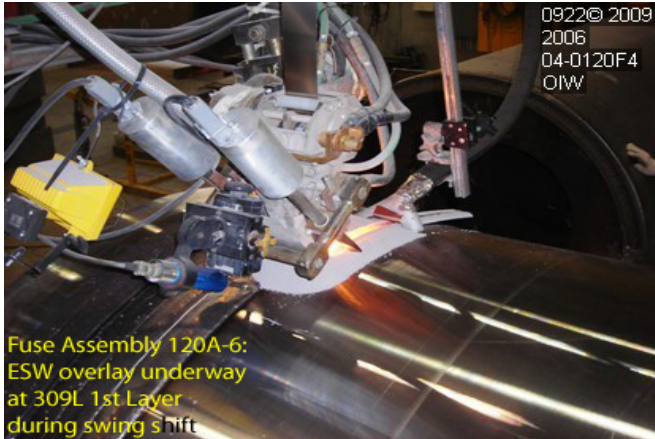
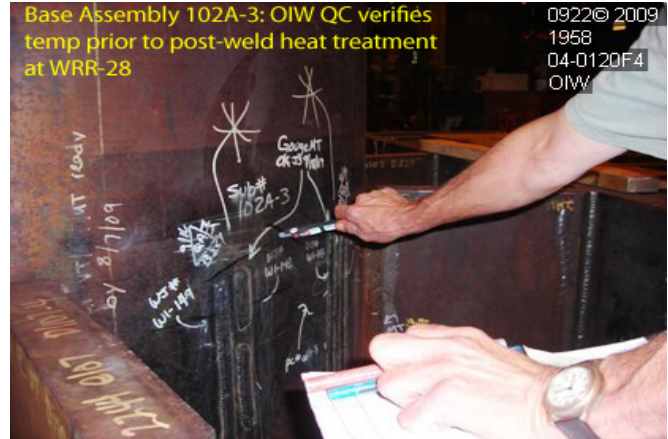
The QA Inspector intermittently monitored OIW welders Phuong Huynh (WID H4) and Yuriy Bannikov (WID B61) as they engaged in grinding at interior weld terminations in an attempt to achieve a 2:1 transition at these locations. Welders H4 & B61 were engaged in this activity for the duration of the shift.

The QA Inspector was contacted by OIW Quality Control Inspector Steve Barnett and informed that three areas on a111-3 forging where base material indications had been previously excavated had undergone Magnetic Particle Testing (MT) on the prepared surface as required by approved Welding Repair Report (WRR-28). Mr. Barnett further stated that he had verified required pre-heat and that welding was set to begin at the referenced locations near weld joints W1-142/143, W1-146/147, & W1-148/149 which respectively join c107, e108 & d108 radial stiffeners to a111-3 forging. OIW welder Mikhail Bannikov (B28) subsequently initiated welding at prepared excavations utilizing Flux Cored Arc Welding (FCAW) and approved Welding Procedure Specification (WPS)

3048. Welder B28 performed FCAW in the vertical (3G) position and maintained continuous preheat utilizing a torch. Mr. Barnett was observed regularly monitoring and recording the in process FCAW parameters for the duration of the repair welding. The QA Inspector also intermittently observed in process welding parameters and determined that the FCAW parameters and minimum preheat/interpass temperature appeared to be in general compliance with the contract requirements -- (25 volts, 225 amperes, 178mm/min travel speed). The QA Inspector verified that specified two hour post-heat of 230°C to 315°C was achieved and maintained at each location. The repair welding described above was completed without incident and appeared to be in general compliance with approved Welding Repair Report (WRR) and contract requirements.

The QA Inspector was contacted upon arrival by OIW QC Inspector Steve Barnett and notified that automatic electro slag welding (ESW) overlay process was about to be initiated on assembly 120A-6. OIW qualified welder Bounheune Savanh (WID S74) was subsequently observed during in-process welding of Soudotape 309L stainless steel overlay to hinge k pipe beam fuse sub-assembly 120A-6. The weld joint is identified as 309L 1st layer. Mr. Savanh was observed welding in the flat position utilizing automatic ESW overlay process with a .5mm x 60mm Soudotape 309L stainless electrode, filler metal brand Soudotape class EQ309L automatic. An OIW helper was observed assisting welder S74 during ESW activity. The QA Inspector observed OIW QC Inspector Steve Barnett regularly monitoring and recording the in process ESW parameters. The QA Inspector also intermittently observed in process welding parameters and determined that the ESW parameters (1200 amps, 25.4 volts, 267mm/min travel speed) and minimum preheat temperature of 225° F appeared to be in general compliance with the contract requirements and approved OIW Welding Procedure Specification (WPS) 7003.
